# **Structural Inspection Report**

**Standalone Garage, Flat 1/1,  
40 Campbell Street,  
Helensburgh**

**Balfour Engineering Consultancy Ltd**

Ref 14538/FD

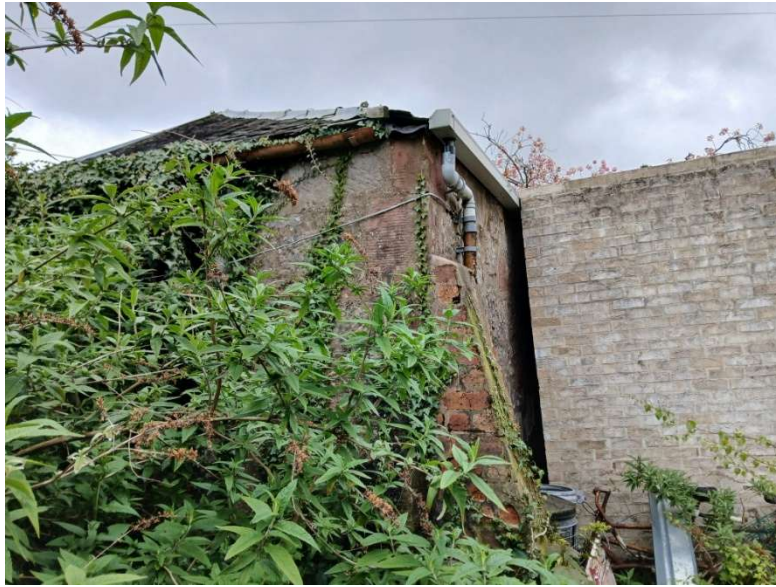
At the south-eastern corner of the building there is a small buttress. Refer to photograph 1. There is also extensive ivy growth.

Photograph No.1 – Partial East Elevation not obscured by neighbouring garage.

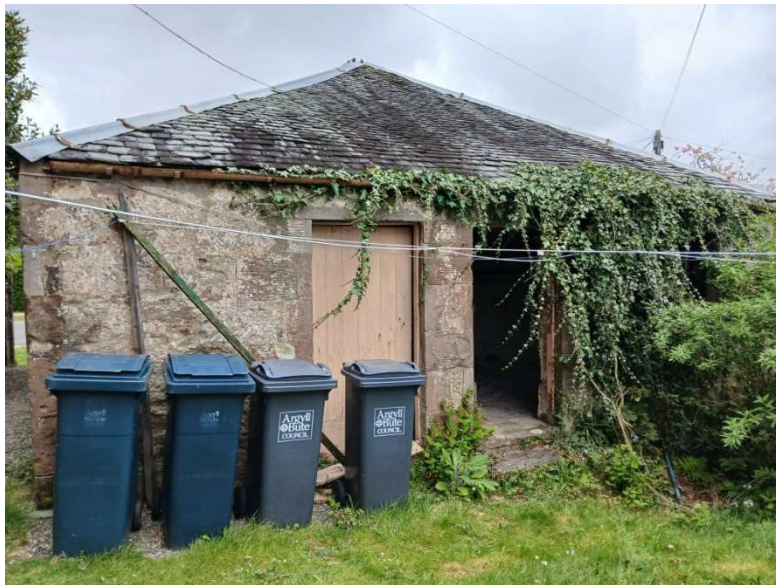
On the southern elevation there is extensive ivy growth obscuring part of the wall and roof. The stonework is in acceptable condition. The roofing slates appear okay. The gutter is in poor condition. There is some minor deformation or movement in the roof finish. Refer to photograph 2.

Photograph No.2 – South (rear) elevation.

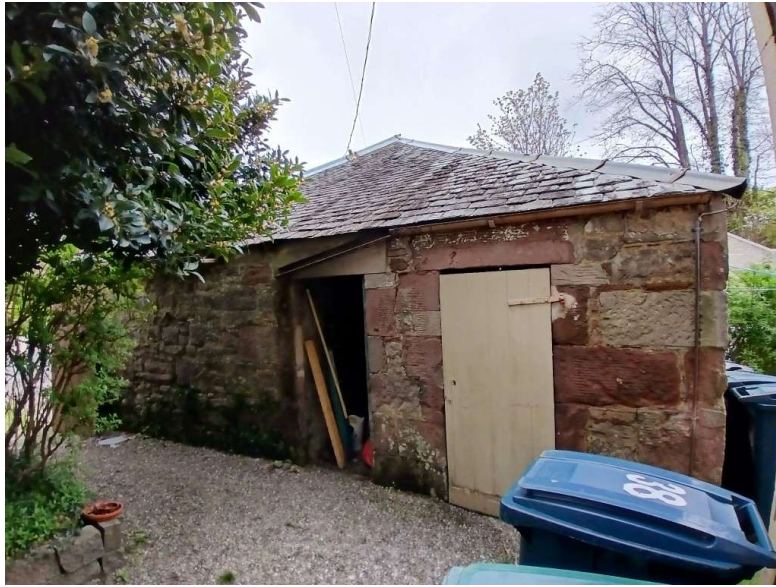
The western elevation stonework and roof appear in similar condition to the southern elevation. Photograph 3.

Photograph No.3 – West elevation

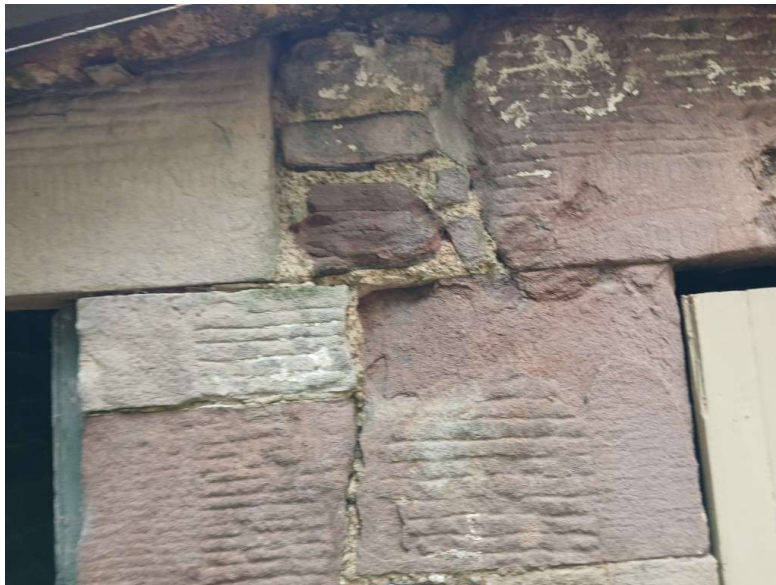
Some weathering and minor deterioration of the stonework was visible in places on the western gable. Photograph 4.

Photograph No.4 – Weathering and deterioration of stonework between doors on west elevation.

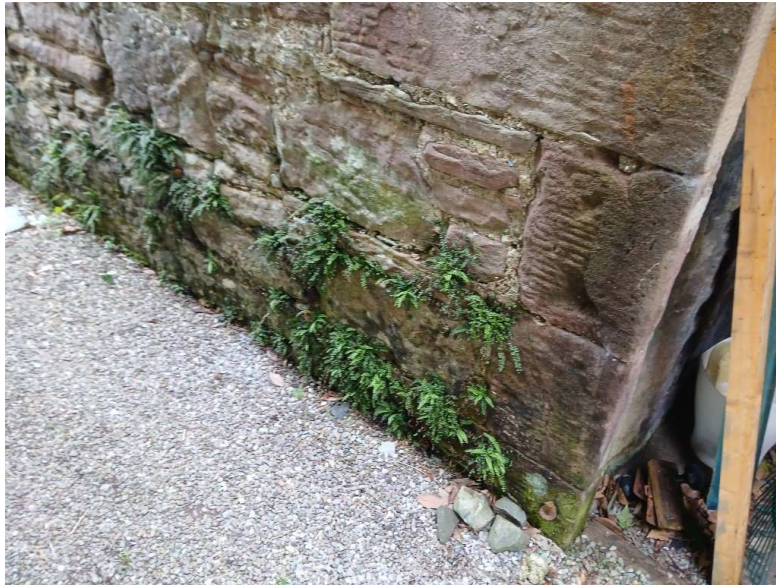
Vegetation could be seen growing in horizontal and perpend mortar bed joints at the base of the wall on the west gable. Photograph 5.

Photograph No.5 – Vegetation growing within bed and perpendicular joints.

- All ivy and plant growths to the walls and roof should be removed. Consideration should be given to the application of a suitable weed inhibitor to prevent further regrowth.
- All of the above ground rainwater goods would need to be inspected, made good and replaced.
- All windows and doors would need to be replaced.

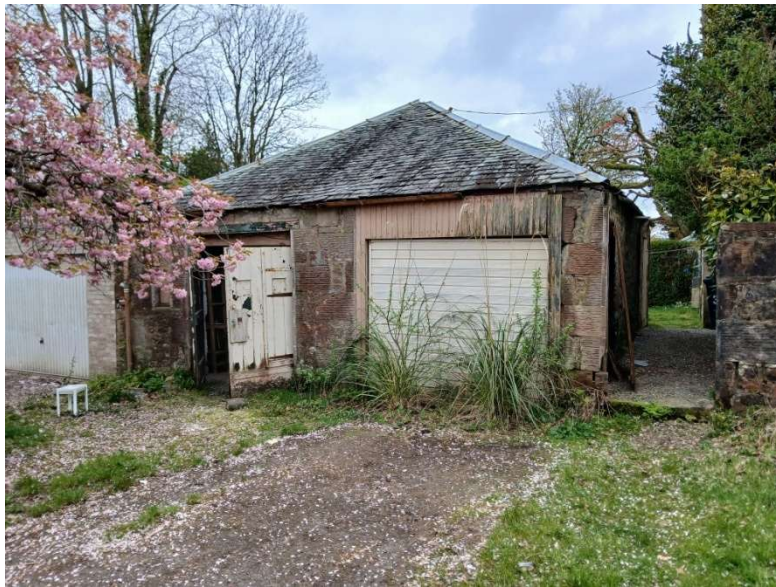
To the front (northern) elevation there are a number of cracks within the stonework mortar joints and dislodged masonry. Some small movement of the roof slope was visible. The rainwater goods were in poor condition. The driveway was partially overgrown. Photograph 6.

Photograph No.6 – North (road) elevation.

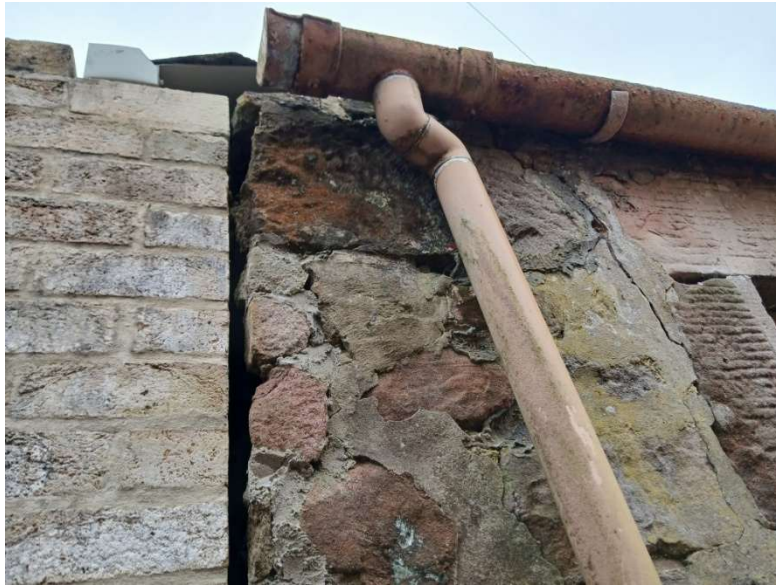
There is a gap between this building and the adjacent newer garage. The gap is inconsistent along the height of the building. There is some dislodged stonework. Refer to photographs 7 – 9.

Photograph No.7 – Close up of head of north-eastern corner adjacent to neighbouring property.

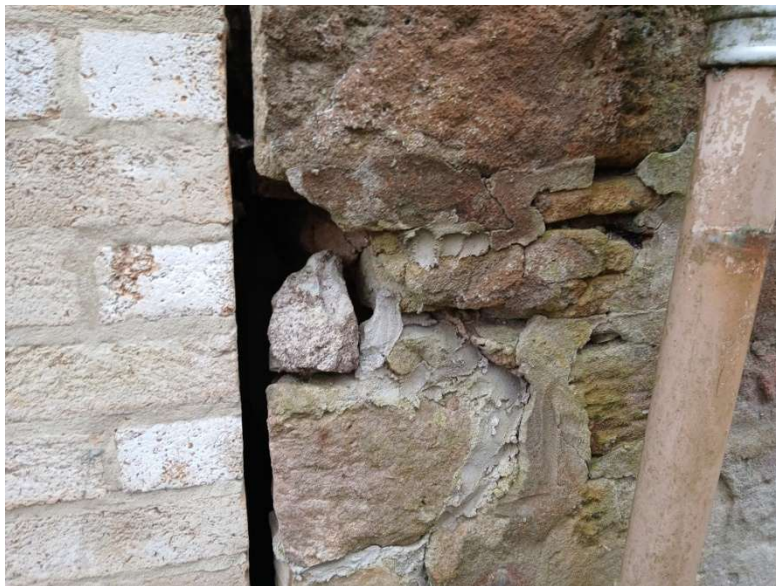
Photograph No.8 – Dislodged masonry below photo 7.

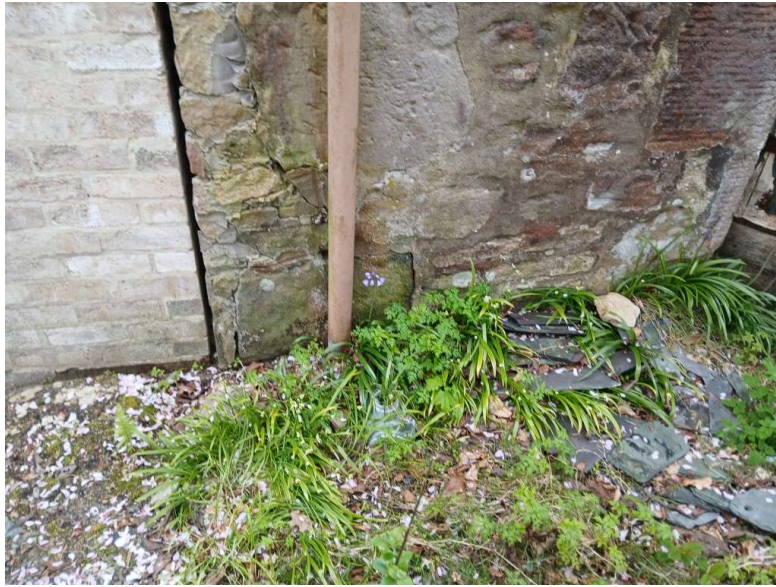
Photograph No.9 – Base of wall below photo 7 & 8.

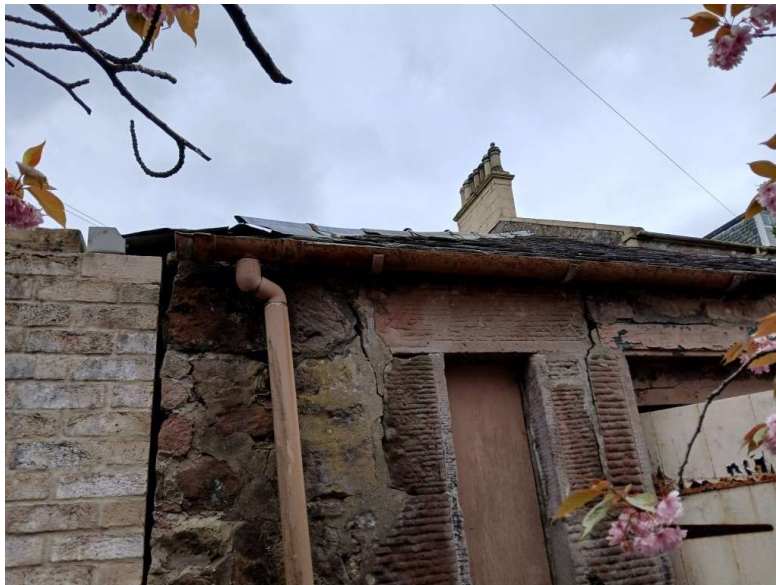
To each side of the small window on the northern elevation there is cracking to each side of the window lintol. There is also opening up of the joints. Refer to photographs 10 & 11.

Photograph No.10 – Cracking to each side of window lintol and opening of joints.

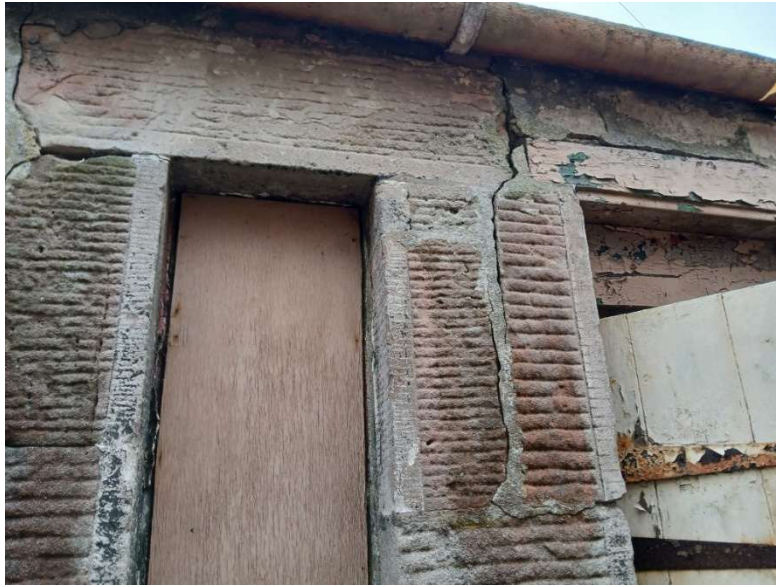
Photograph No.11 – Close up as photo 10.

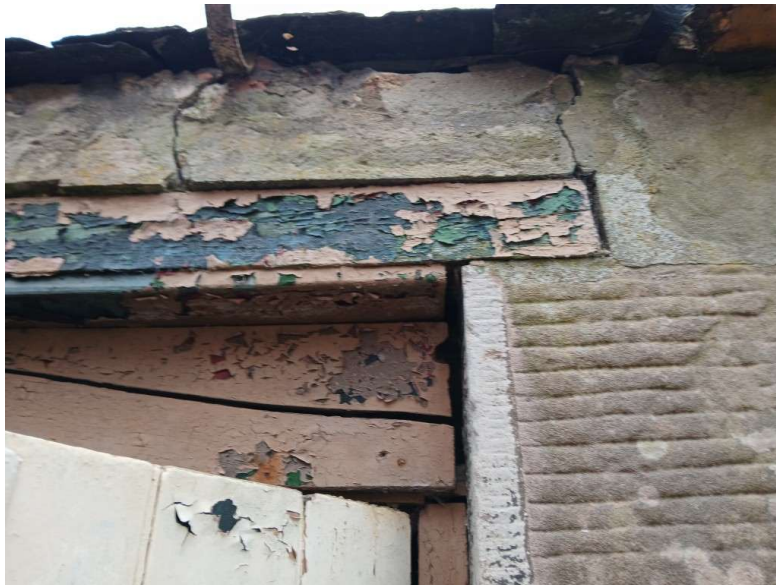
Above the main eastern garage door the mortar joints have opened up. The timber elements are in poor condition. Photograph 12.

Photograph No.12 – Split in timber to lower lintol above door, flaking paint to upper lintol, opening up of joints in stonework above lintol.

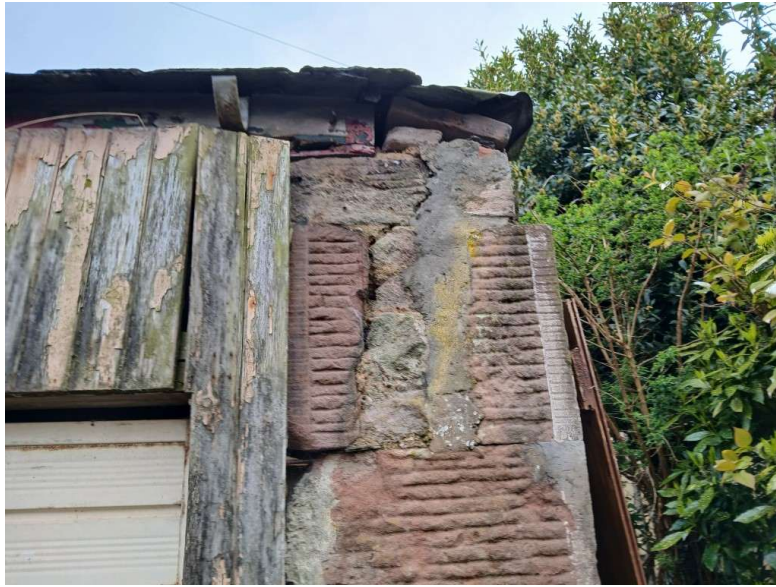
To the western side of the western garage door there is opening up of the masonry elements and the timbers are in poor condition. Photograph 13.

Photograph No.13 – Opening up of joints in masonry to north-western corner of building and timbers above door in poor condition.

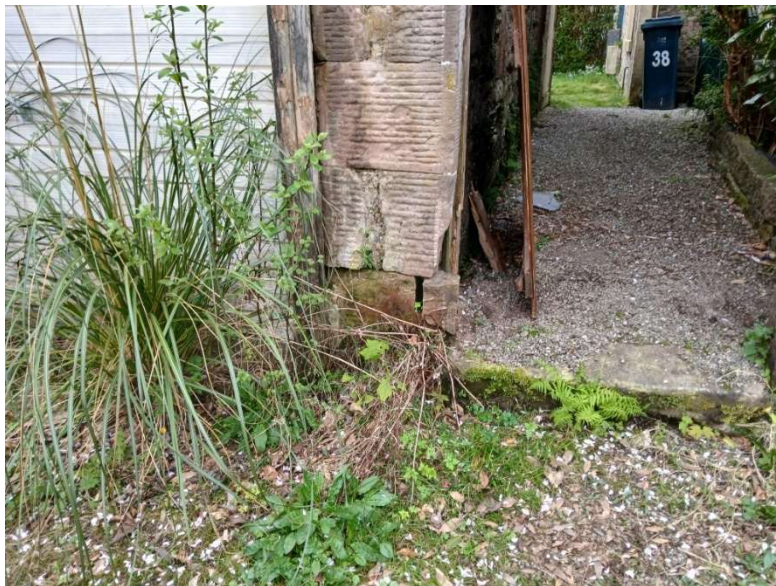
Masonry is dislodged and there is vegetation growths at the base of the north-western corner of the building. Photograph 14.

Photograph No.14 – Cracked and dislodged masonry at base course to north-western corner of building.

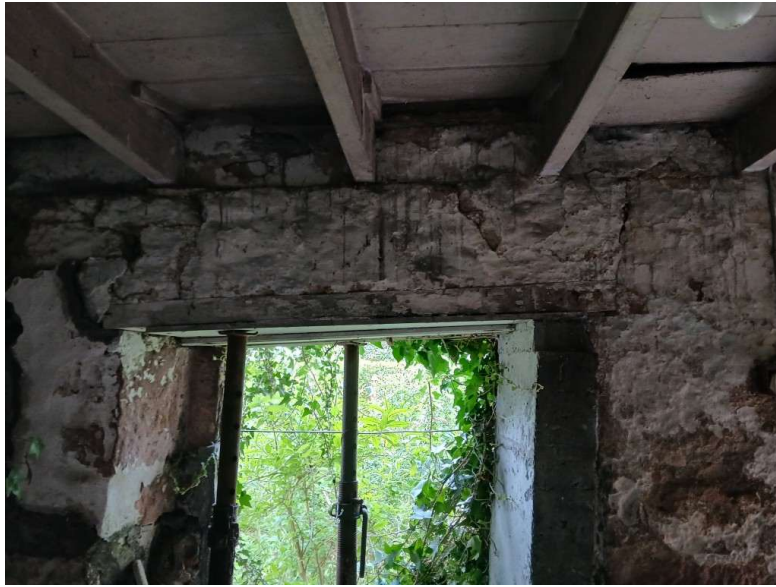
To the interior of the room space on the southern side of the building there are timber props install to the window lintol. Cracking is visible to each side of the lintol along with partially dislodged masonry. There is also vegetation beginning to grow within the building. Photographs 15 & 16.

Photograph No.15 – Southern wall, internal. Window lintol propped in two places.

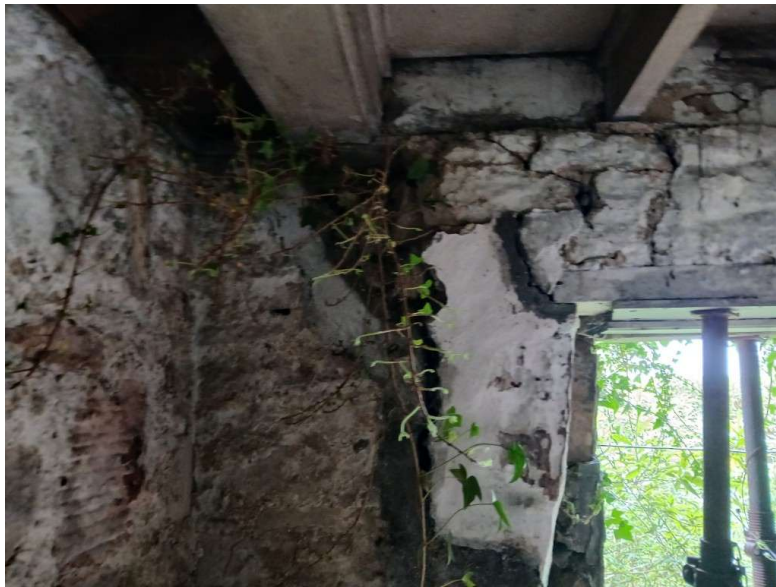
Photograph No.16 – Cracking and dislodged masonry at south-eastern corner and vegetation growing inside building.

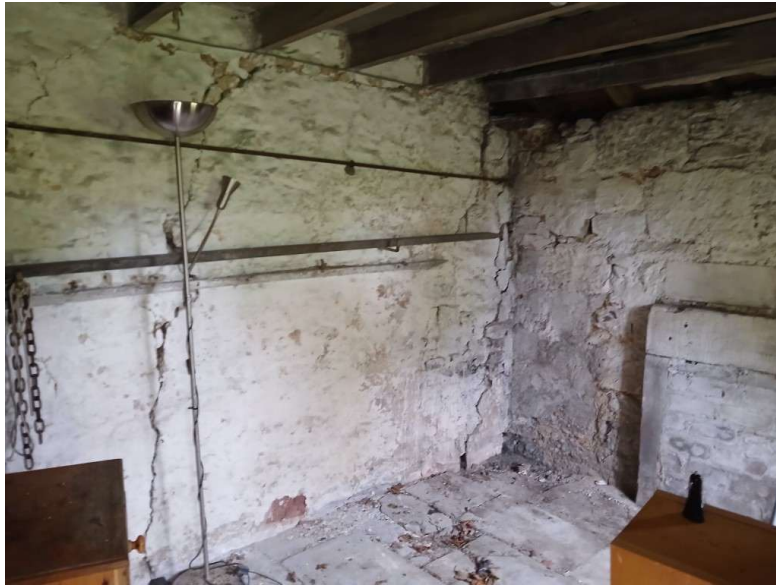
To the dividing wall between the northern and southern parts of the building there is a stone wall. The wall is cracking in a number of places and is dislodged from the eastern gable wall. The flagstone covered floor dips from west to east across the length of the building. Photograph 17.

Photograph No.17 – Interior of southern portion of building viewing dividing wall running east-west. Extensive cracking visible and sloping of flagstone floor towards eastern gable.

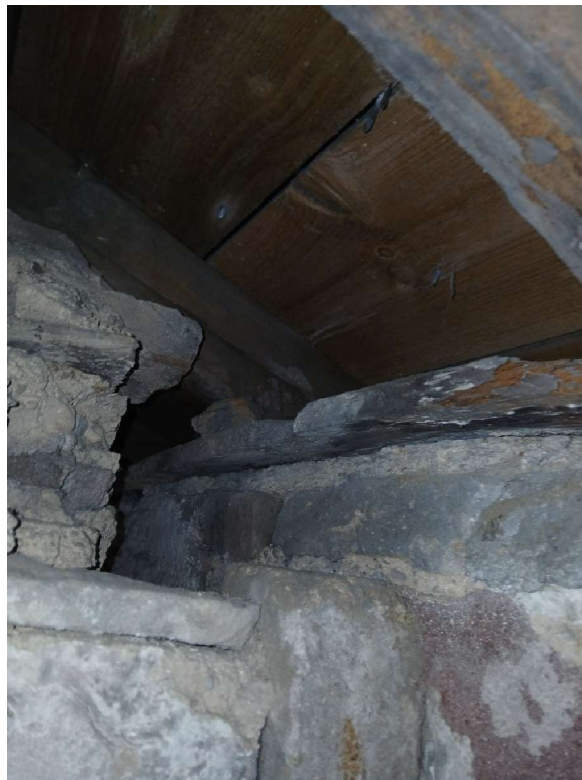
Some sign of woodboring insects was noted within deteriorated timber elements forming the roof structure. Photograph 18.

Photograph No.18 – Deterioration of timber and sign of woodworm visible on eastern gable

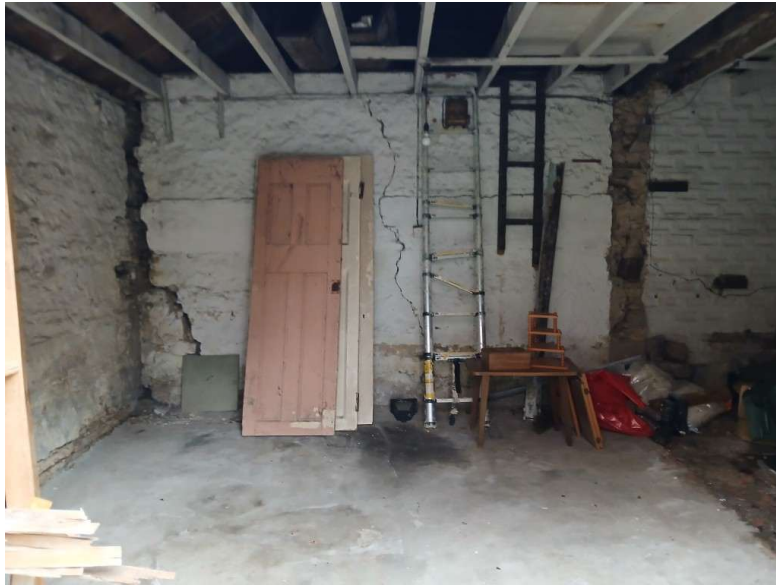
To the northern portion of the building within the former garage spaces the internal wall the cracks noted on the southern side are visible here. The dislodgement of this wall from the eastern gable is more pronounced, with a gap of around 110mm in places. Refer to photographs 19 – 21.

Photograph No.19 – Northern face of internal wall at eastern end. Large crack at intersection of eastern gable.

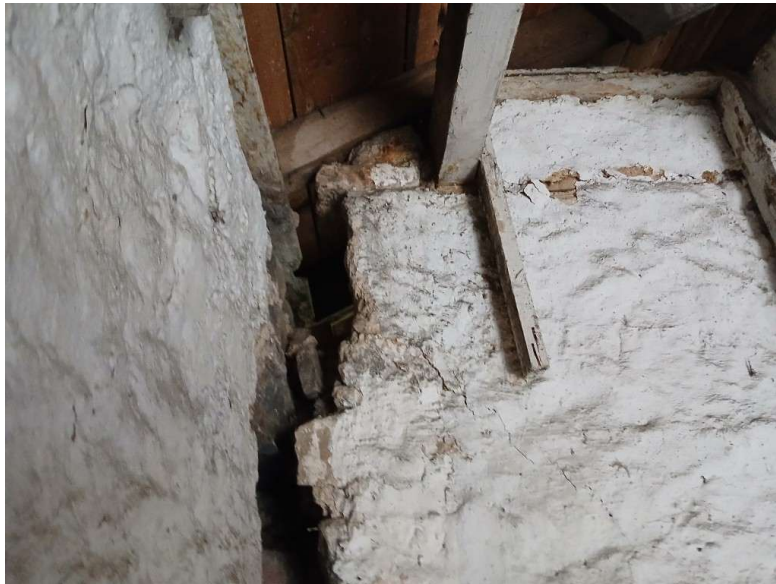
Photograph No.20 – Close up of head of wall as photo 19.

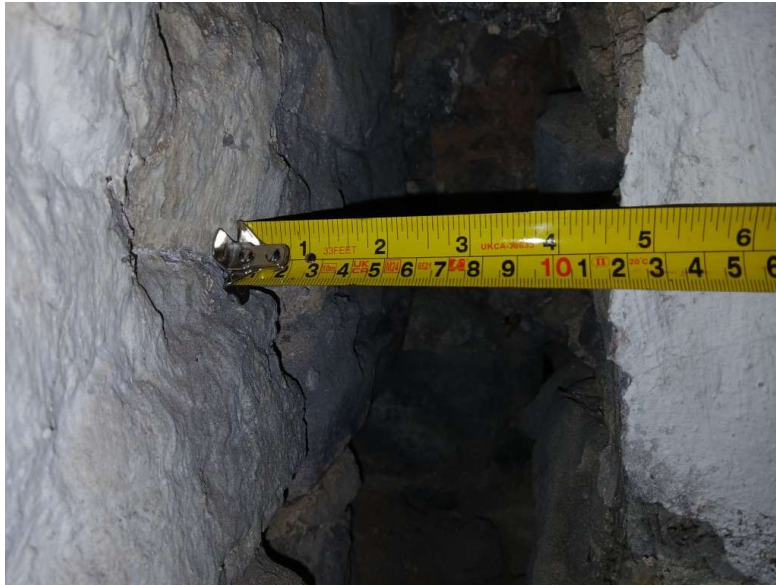
Photograph No.21 – 110mm gap at opening up/crack as photo 19.

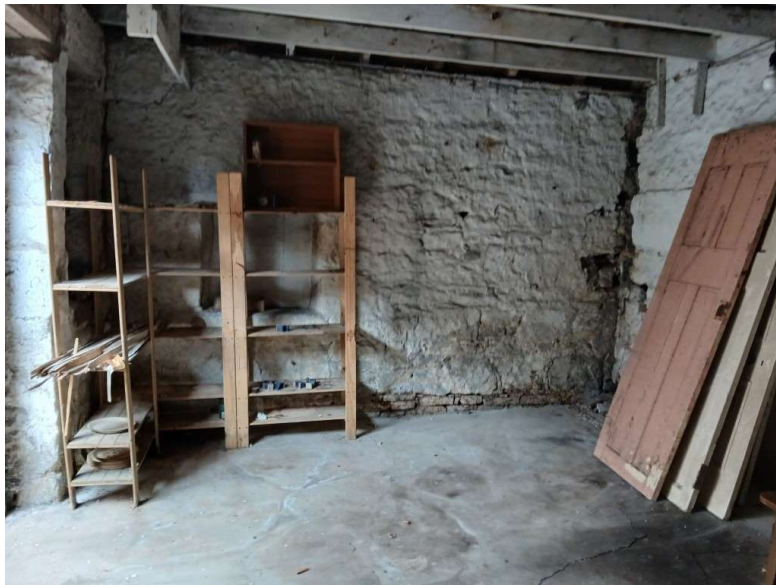
General view of eastern gable wall showing former window closed up at some point in the past. The concrete floor slab is in poor condition with extensive cracking running in many directions across the extent of the slab. Photographs 22 & 23.

Photograph No.22 – Eastern gable wall. Concrete slab sloping towards northern side.

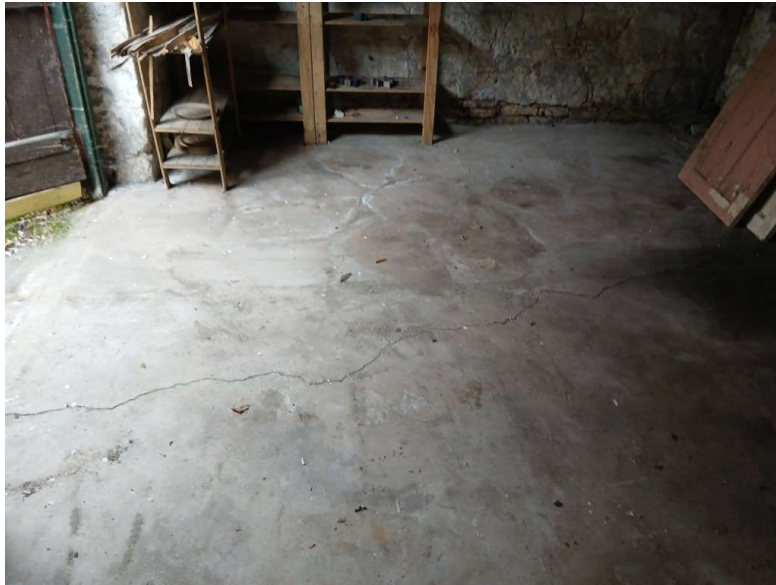
The concrete floor slab within the northern side of the building is badly cracked and there is a section missing where a wall has been taken down in the past. The cracking is suggestive of movement and at one area there may have been some impact damage. Ultimately the slab could not be saved and would need to be replaced.

Photograph No.23 – Cracking noted across full extent of concrete floor slab.

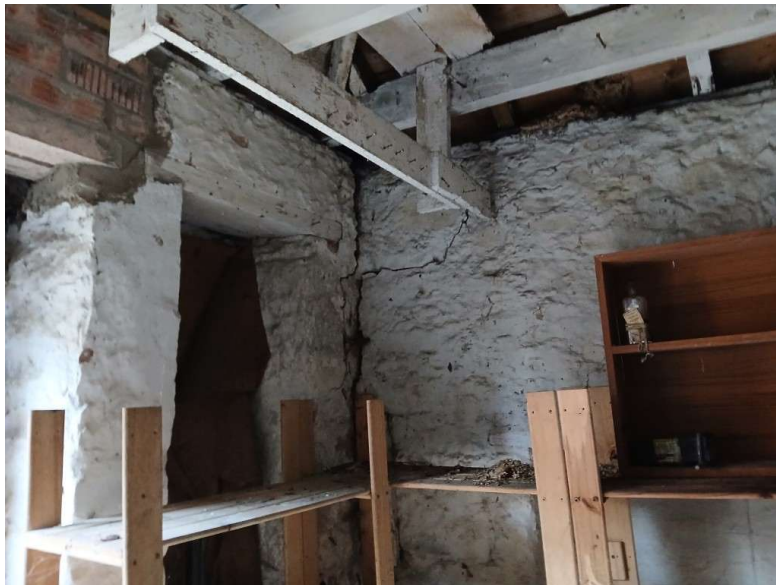
There is a vertical crack or displacement between the northern wall and the eastern gable elevation. Photograph 24.

Photograph No.24 – Opening up at intersection of north and east walls.

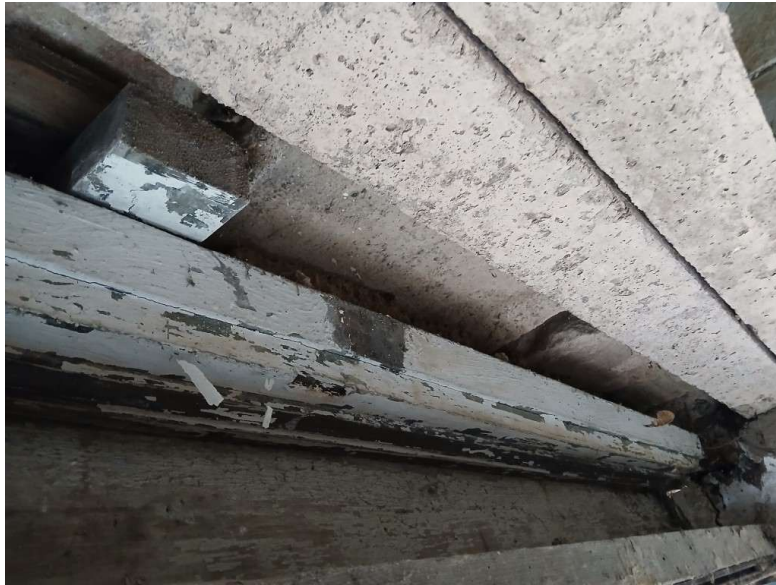
At the eastern garage door, newer precast concrete lintols have been installed to the interior at some point in the past. The stonework to the exterior of the walling is only partially supported on the precast concrete lintols, with load being shared by timber framing. Photograph 25.

At the eastern garage door the external stonework is currently supported on some timber members which in turn appear in poor condition. The internal parts of the wall are supported on newer precast concrete lintols which appear to be adequate. The defective outer lintols would need to be replaced.

Photograph No.25 – Stone to outer leaf partially supported on external timber lintol and internal precast concrete lintol.

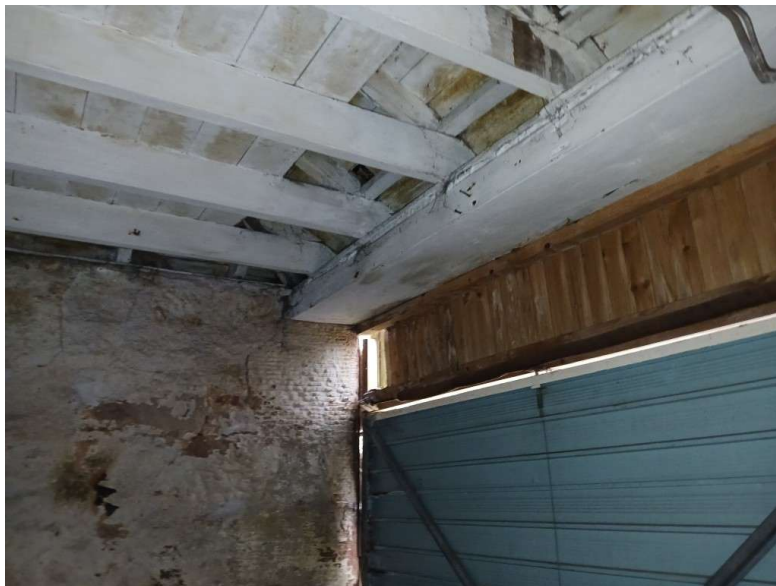
The condition of the lintol and suitability of supports to masonry over the western garage door could not be confirmed. No obvious defects were noted to the timber roof structure in this area. Photograph 26.

Photograph No.26 – Timbers to roof appear in reasonable condition. Safe lintol not visible condition unknown.

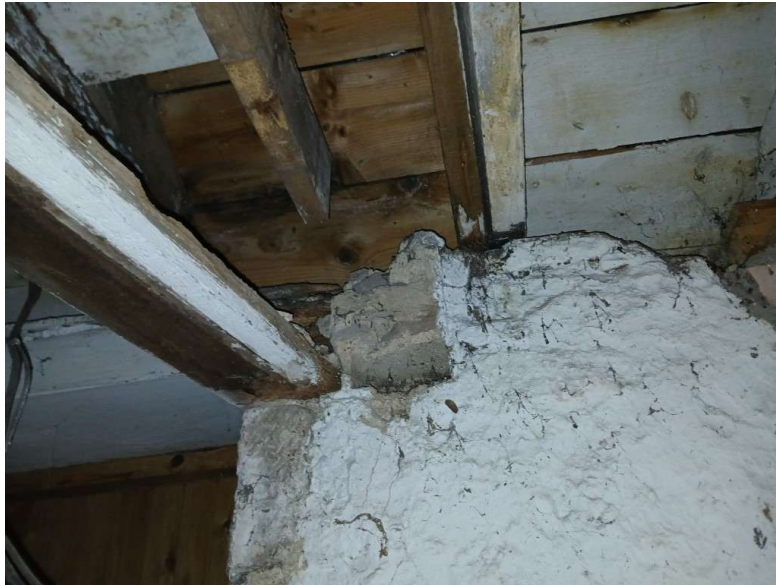
A timber ceiling joist was unsupported at both ends above the former dividing wall between garage sections. Photographs 27 & 30.

Photograph No.27 – Unsupported ceiling joist.

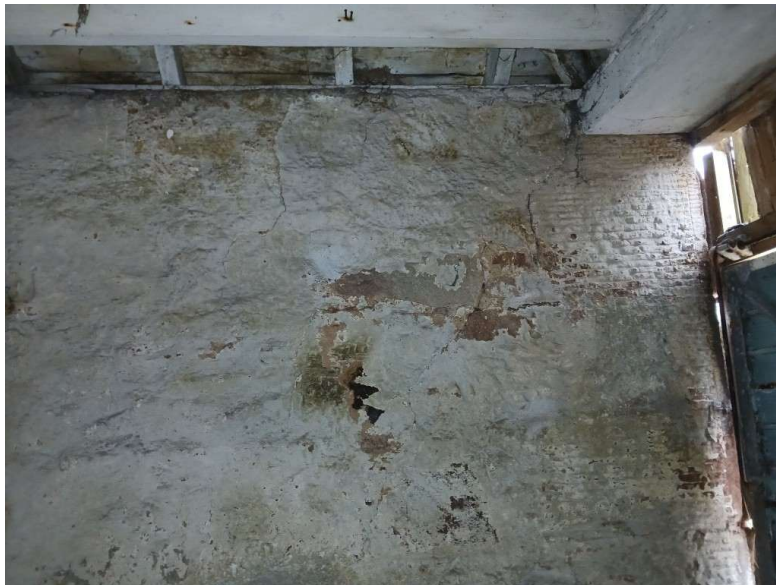
On the western elevation a crack could be seen in the masonry. Photograph 28.

Photograph No.28 – Vertical crack to internal face of west gable.

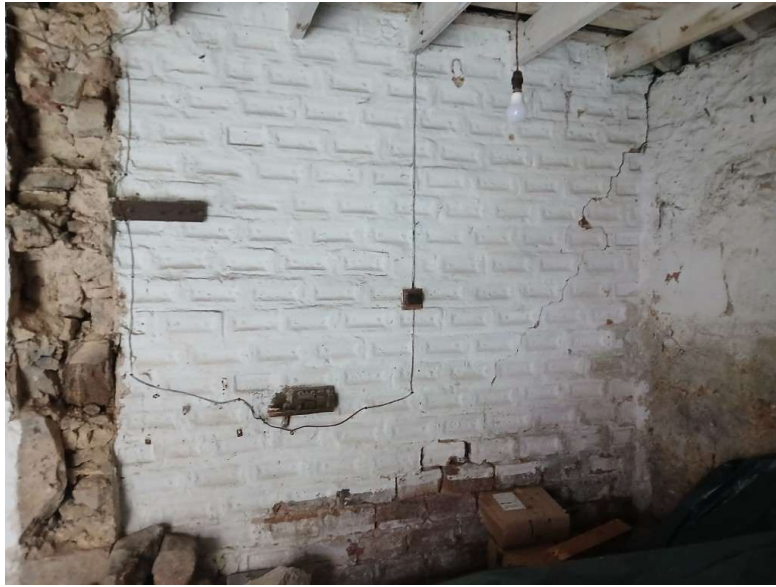
The western end of the internal dividing wall has been constructed with brickwork. The bricks have been laid on their sides ie not in the standard orientation. Photograph 29.

Photograph No.29 – West end of internal wall. Constructed with bricks on their side, step cracking in walling.

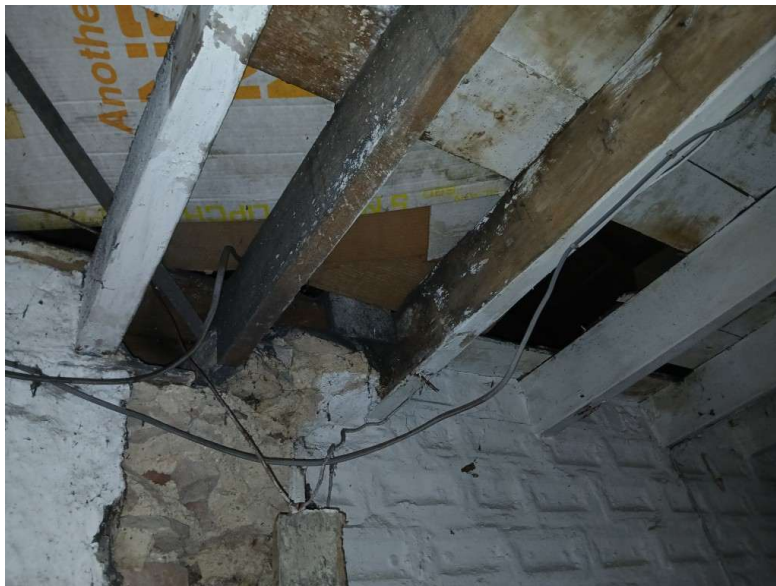
Photograph No.30 – Unsupported joist end at former dividing wall location.

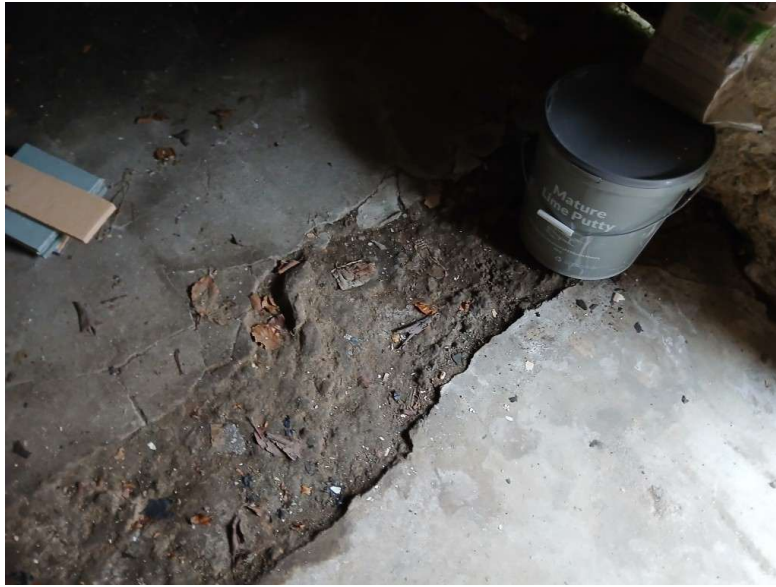
Where a dividing wall has been taken down the floor has not been infilled. Photograph 31.

Photograph No.31 – No infill provided to flooring at former dividing wall.

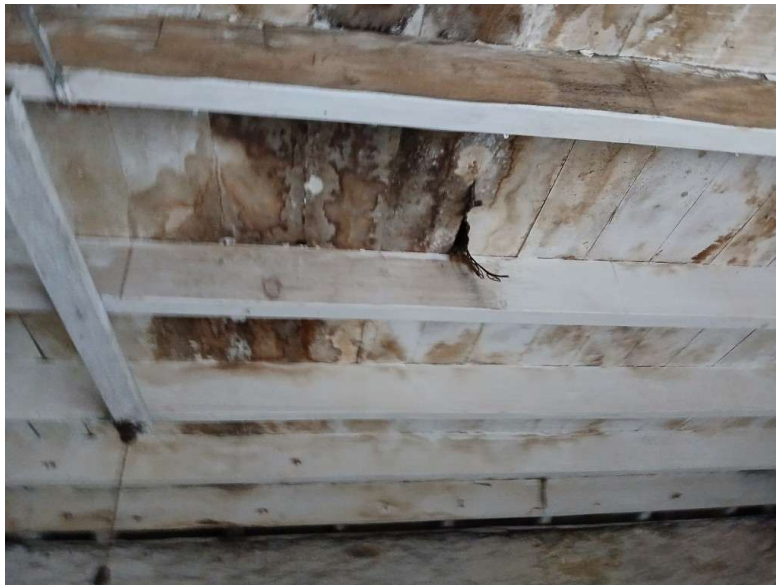
The timber roof structure condition varies throughout. With some damp staining, water penetration, holes in the roof and warped timbers. Photographs 32 – 35.

Photograph No.32 – Timber elements in .poor condition.

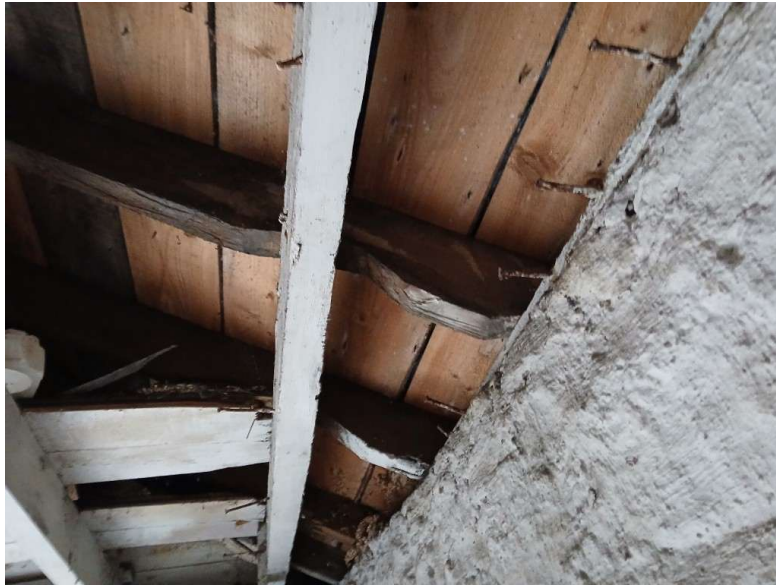
Photograph No.33 – Condition of timber elements various throughout the roof structure.

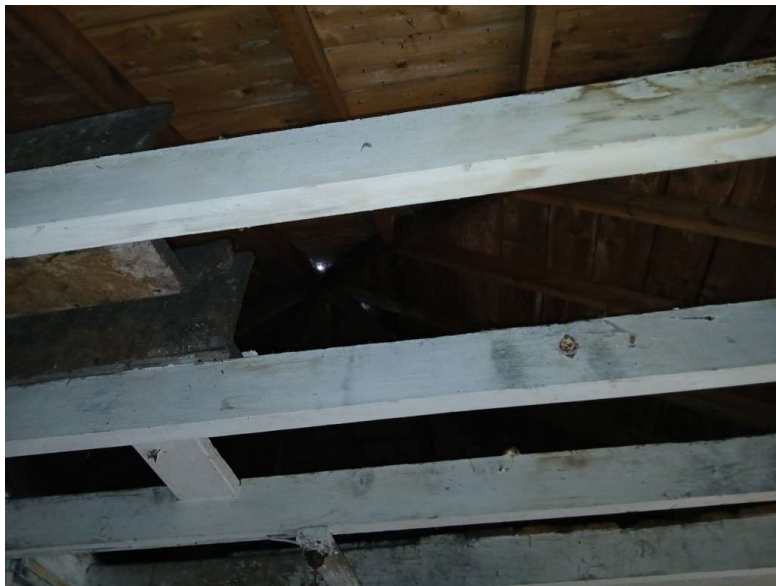
Photograph No.34 – Light visible indicating at least one hole in roof slope.

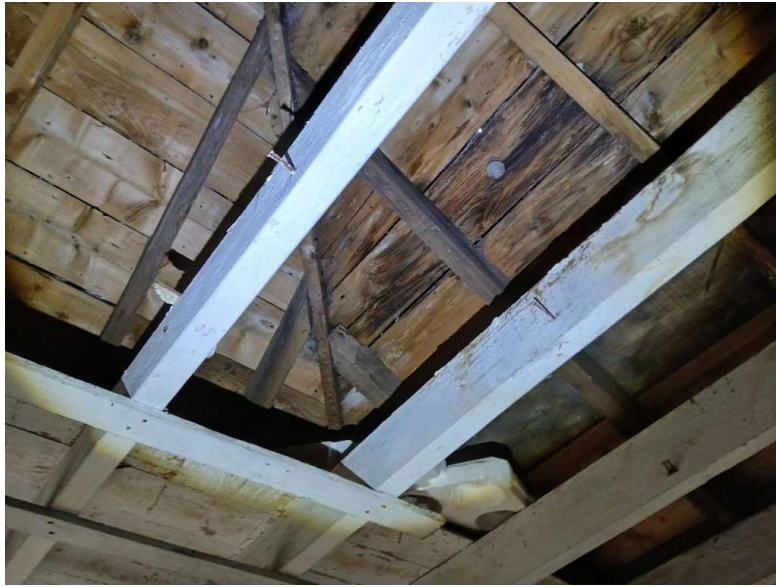
Photograph No.35 – Damp staining to timber elements.
