Portmore Place, Main Street, Tobermory, front elevation.

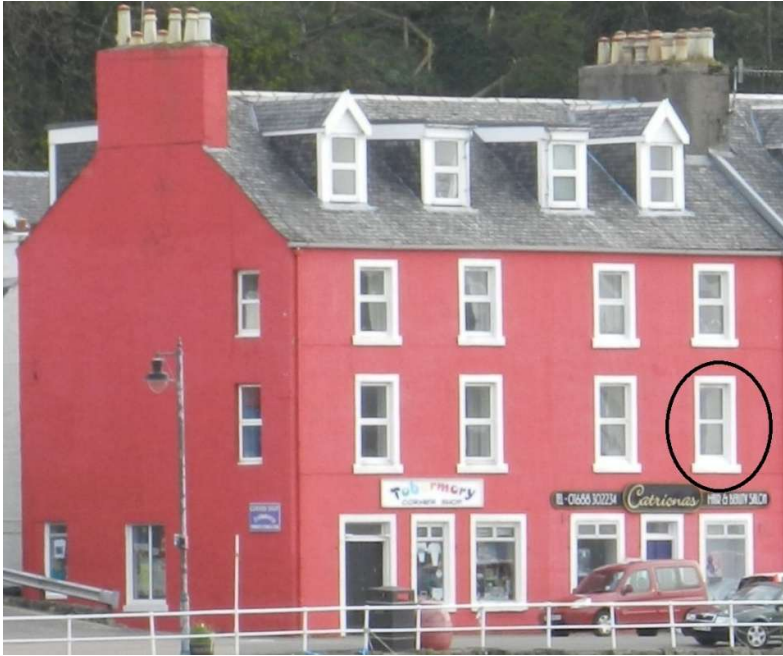
Fig 1

Showing the front/seaward elevation of the property. The circle is highlighting the broken uPVC tilt/turn window which I would like to replace as a uPVC sash window.

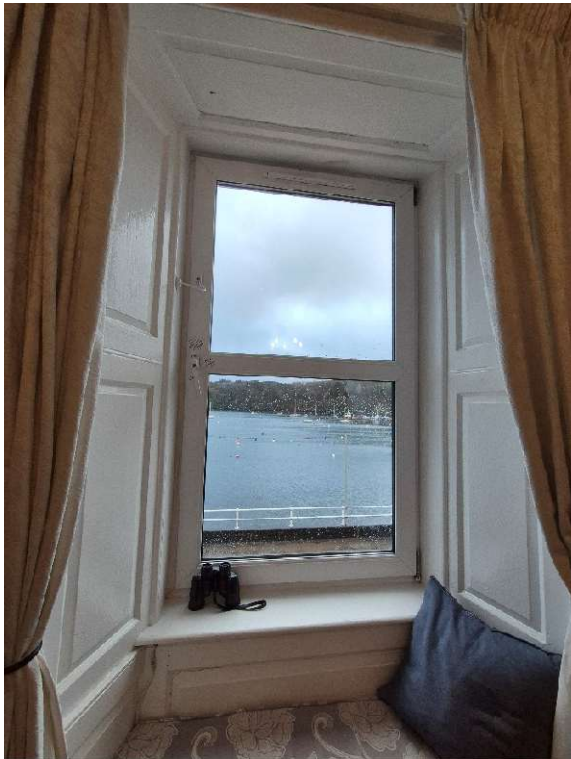
Fig 2 shows the window from the inside of the property.

The window has become detached from its top right bracket. It is a heavy window, now hinged only by the bottom right bracket which is unsafe.

Discussion with a window expert has resulted in his recommendation to replace it with a uPVC sash window, which will comply with both fire and cleaning regulations.

While it is possible to replace with a tilt/turn window again. The size and weight of the window is likely to attract the same issue.

Sash windows were the original windows, and replacement with a white uPVC sash window will retain the appearance of the building from outside.

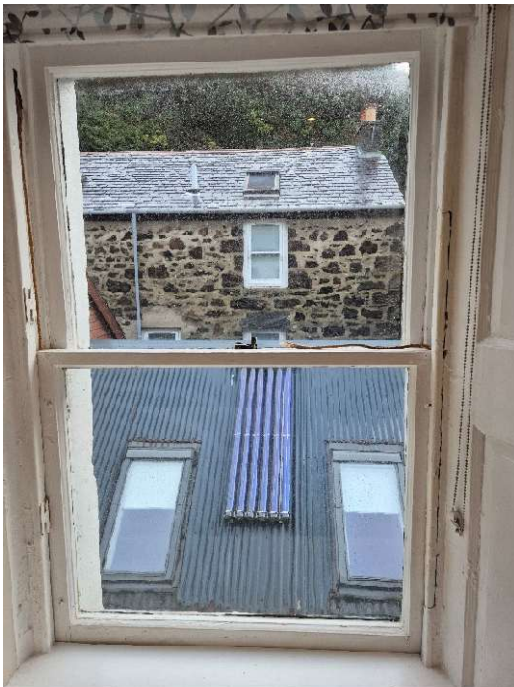
Fig 4

The rear of the property has the old original single-glazed wooden, white painted, sash windows. I would like to replace these with the same double glazed uPVC sash windows.

Figs 4 & 5 show the condition of the windows which require repair or replacement. The EPC recommendations are to replace these windows with double glazing. I propose installing the Veka Imagine windows in white as replacements because they are like-for-like in function and appearance. There will be no change to the appearance of the building from the outside.
