**Regenerating Craignish Rainforest Habitats  
Phase 1: Rainforest Restoration Fund  
Dec 2025 – March 2026**

**Peatland Restoration**

| <b>Project Name:</b> | Peatland Restoration – Craignish |

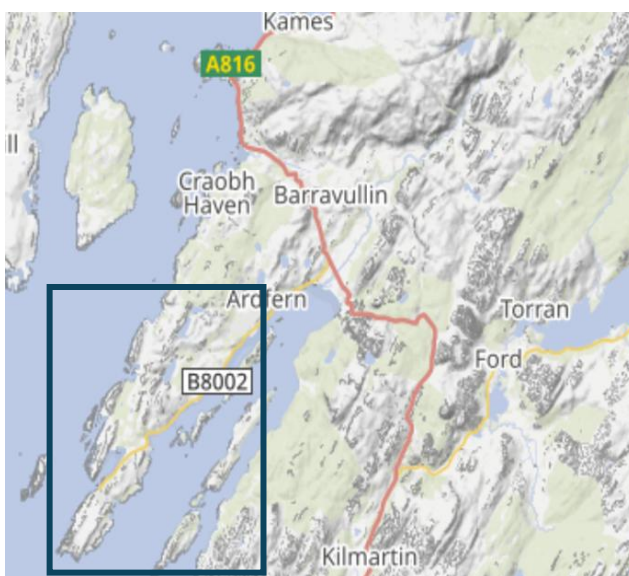
Map 1: Phase 1 Project Delivery Area

Rainforest Restoration Funding (RRF) has been awarded to undertake a variety of activities between December 2025 and the end of March 2026 for the first phase of proposed restoration works within the blue outline in Map 1, including peatland restoration at two properties: Achanarnich and High Corranmor (2 sites).

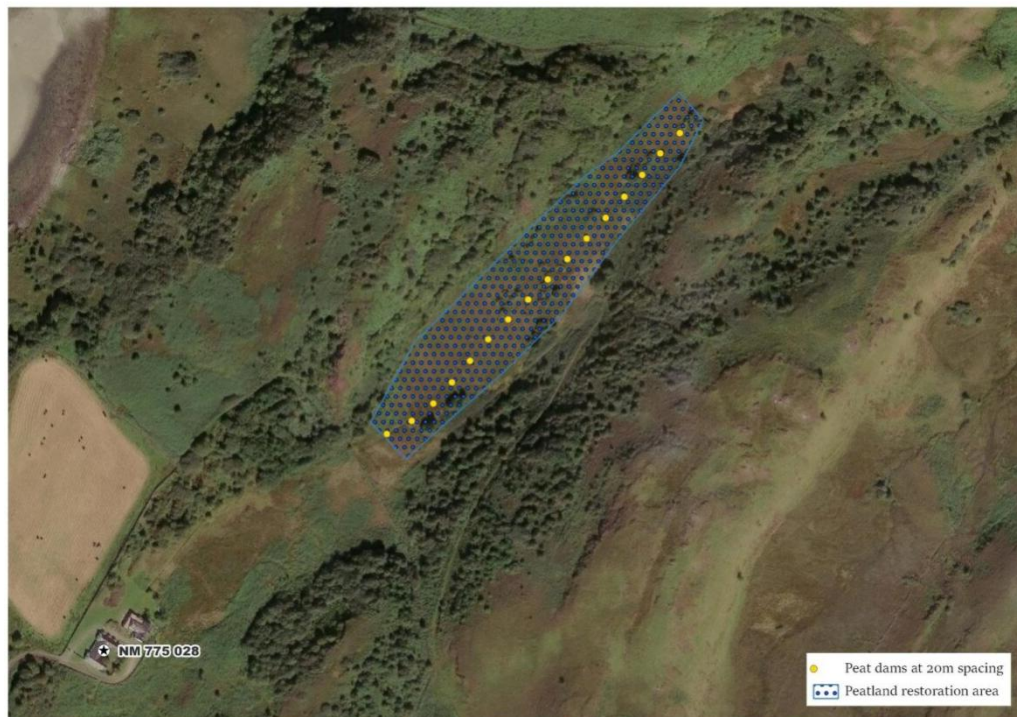
Figure 1: Detail of peat restoration site at Achanarnich

| <b>Watercourses</b> | The restoration works will be undertaken on a historic artificial drain running through the site for a length of approximately 350m | The proposed works will not impact on any natural existing watercourses but will assist with the recovery of the natural hydrology of the wider area. |

It is therefore proposed to install peat and timber dams at 20m intervals along the courses of the principal ditches through both sites to improve the quality of the existing peat, assist the recovery of the associated vegetation and ultimately encourage new peat formation. This will involve construction of 18 dams at Achanarnich and 80 at High Corranmor.

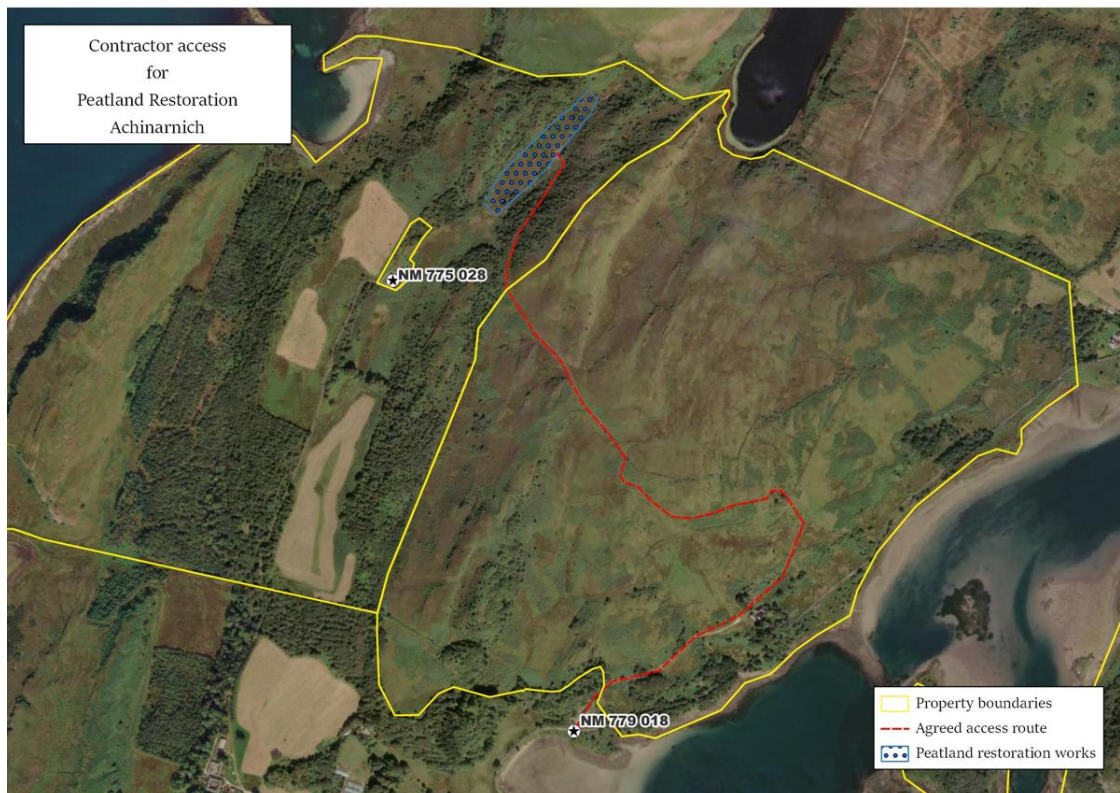
Figure 3: Agreed Access route for Achinarnich:

- Access routes for machinery will be pre-agreed with the Woodland Trust and the landowner prior to works commencing.
- No unauthorised access routes will be used to avoid damage to peatland habitats.
- Machinery will remain outside of ditches at all times and will only cross ditches at pre-agreed crossing points.
- Works will be planned to avoid periods of very wet weather to minimise rutting, peat displacement, and sediment mobilisation.
- Sensitive areas identified by the Woodland Trust will be clearly marked and avoided throughout the works.
  - The access routes will follow the routes shown in Figures 3 and 4 and be will be re-instated following completion of the works.

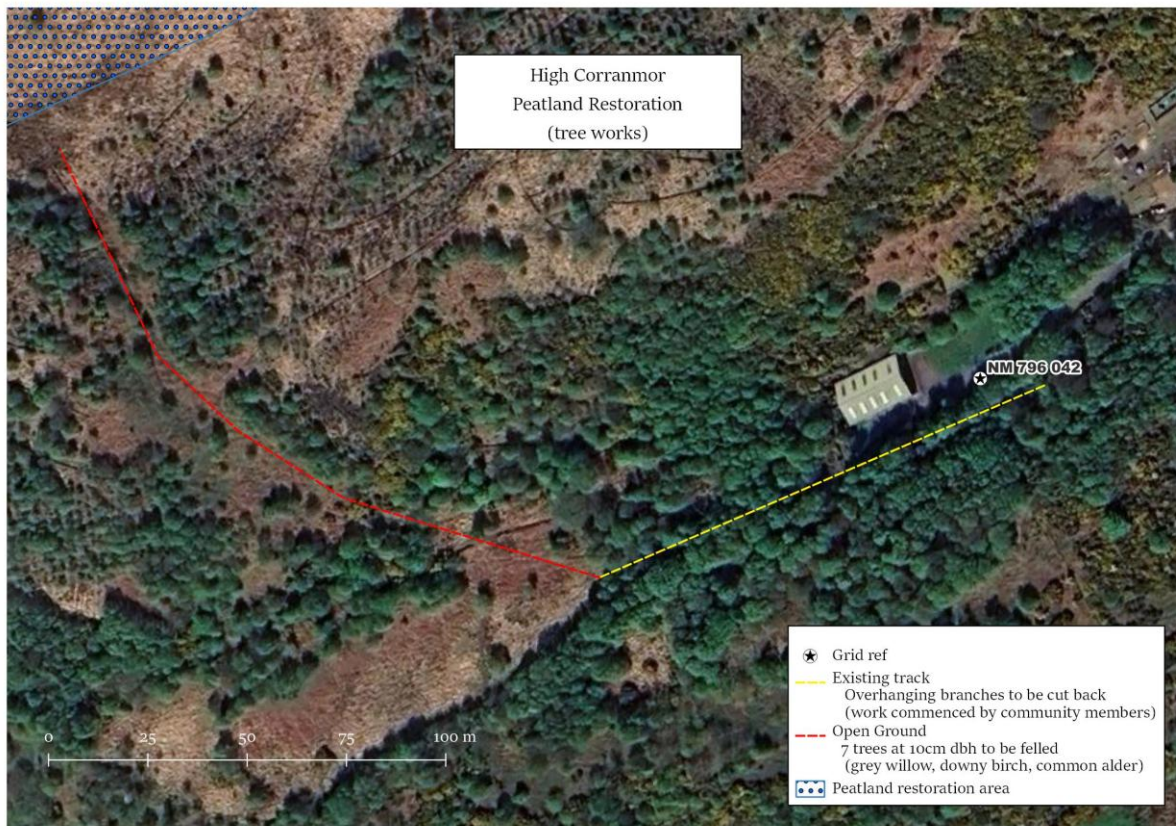
Refer to Figure 5. A total of 7 trees (DBH 10cm or below) will be removed to allow access for plant to the High Corranmor sites (along the red dashed line shown on Figure 7). Some additional crown lifting and tipping back of overhanging branches will be undertaken along the existing access (yellow dashed line).

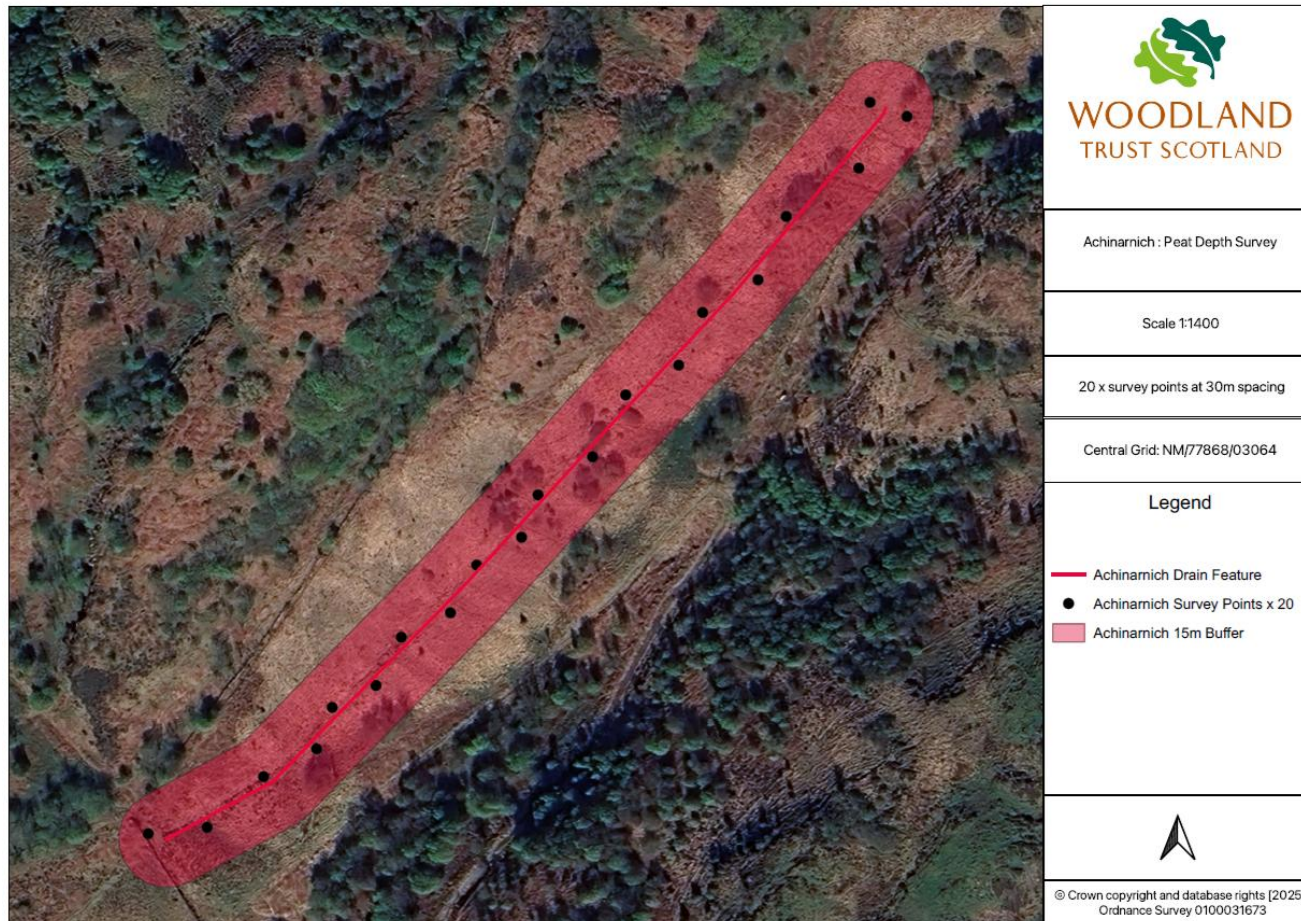
### Achanarnich

Peat depth surveys of the areas to be restored were carried out over the 4 and 5 February 2026. See **Appendix 1** for details for peat depths at Achanarnich, High Corranmor South and High Corranmor North. Peat depths ranges for the three sites are shown in Table 1 below:

The survey results for all sites indicate varying peat depths across all sites with the shallowest peats found at High Corranmor and the deepest at Achanarnich. At all three sites artificial drainage has increased drainage over a long period of time, consequently altering water-levels, peat quality and associated vegetation as a result.
