**Job:**  
106.1  
Airds House  
Port Appin  
By Oban

**Title:**  
Main Block East Elevation  
As Proposed

**Dwg. No:**  
106.1  
F2-P-E1  
Rev A

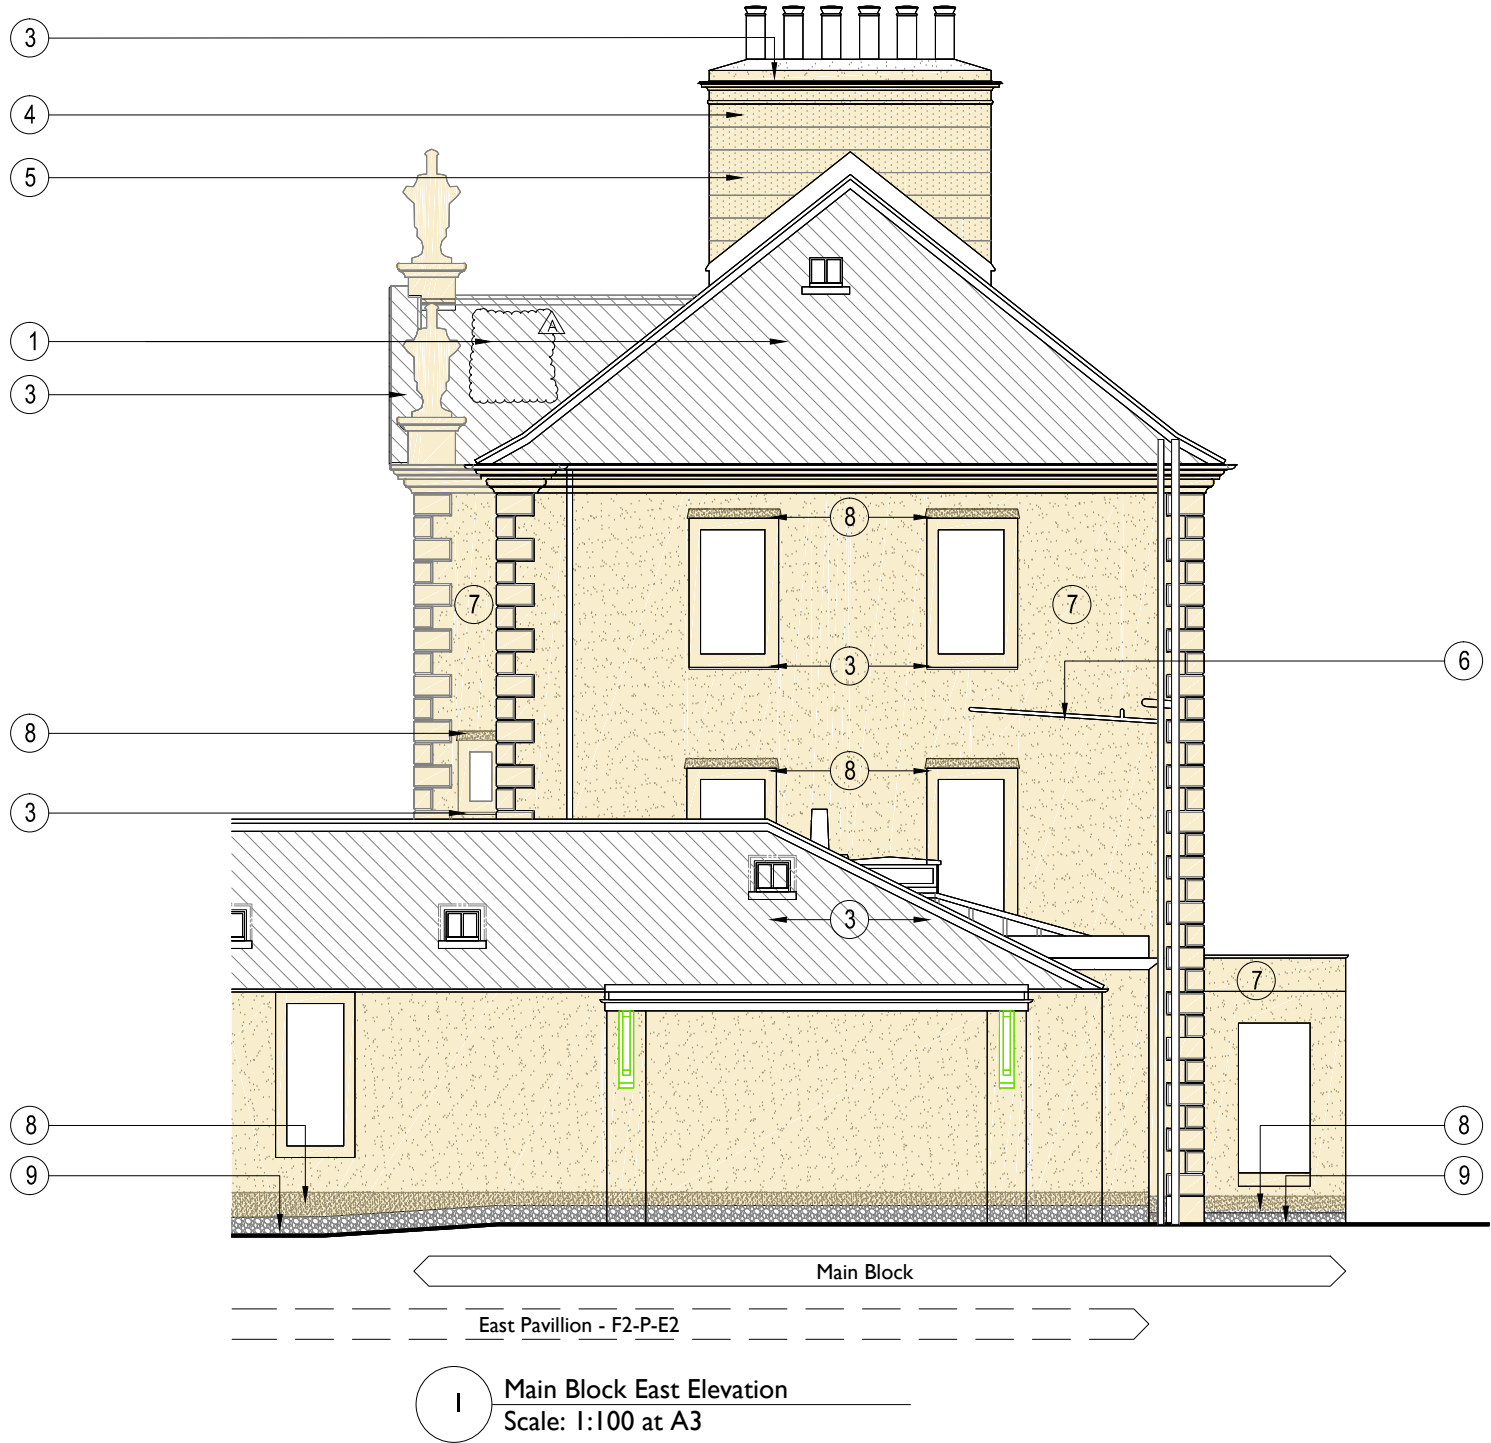
- Roof to be reslated with new British slates of Scottish weight & appearance and in diminishing courses and random widths not less than 150mm wide
- Existing lead valley/parapet gutter to be renewed with Code 6 or 7 lead

- New Code 6 lead covering and/or 45° 25mm drip to stoneworks
- Existing chimney to be repaired and rebuilt - assessment is the top 2 courses. Stones and cans re-used where possible, geologically matched new stone and new matching cans. New terracotta ventilating covers to unused flues lime:sand mortar to all pointing and haunching to copes etc.

- Ashlar stonework to be repointed in NHL3 or 5 lime:sand pointing
- Existing cast iron soil pipes will be redecorated. Plastic pipes to be replaced with cast iron and drainage routes to be simplified

- All existing rubble repointed in lime:sand pointing. Lime:sand harl/render, mix assessed by assessment of original areas found still in situ. Limewash finish, colour based on original paint layer analysis

- Stainless steel bell cast render stop under render
- Existing rubble exposed at base of wall, flush re-pointed in NHL 3.5 Lime:sand mortar and left unharled to aid drying of wall core
